Manhole Inspection Summary

Manhole # S110__011MH

Inspection Is Incomplete Rating: **4) Poor**

Location Address: **319 S Caton Ave**

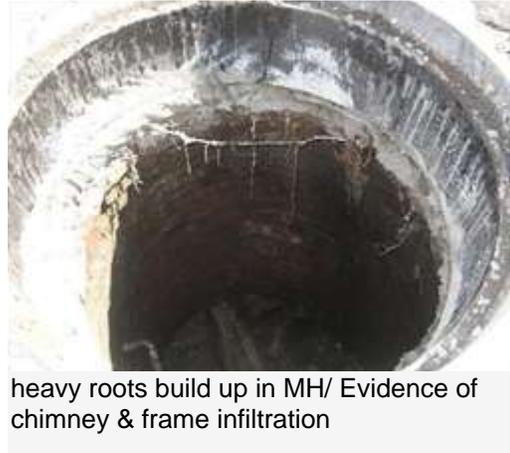
Defect 5

heavy roots build up in MH/ Evidence of chimney & frame infiltration

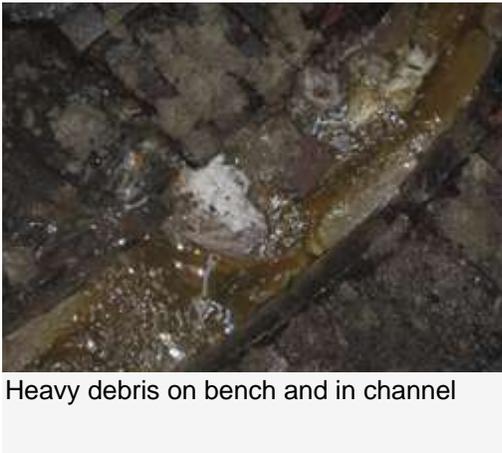
Defect 3

Heavy debris on bench and in channel

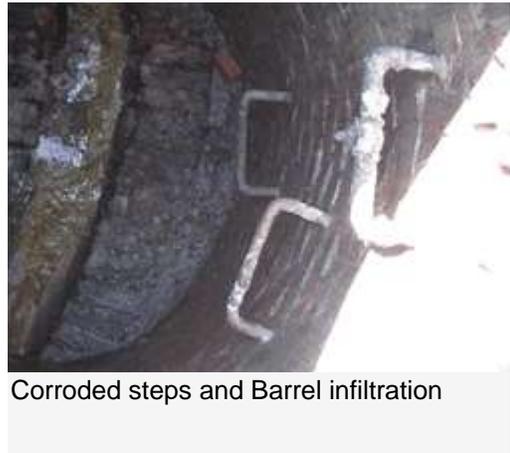
Defect 2

Corroded steps and Barrel infiltration

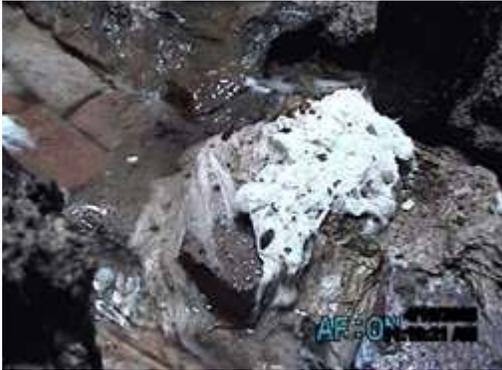
Defect 1

Heavy debris on bench and in channel

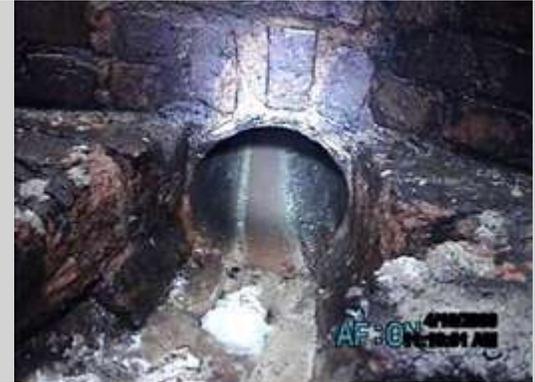
12 O'Clock Outflow

Pipe Height: **7.2** (in.) Rod and Bar (Angled)
Pipe Material: **Clay** Pipe Lined
Invert Depth: **7.70** (ft.) Flow Characteristics: **Slow**
Deposits: None Mud **Sludge** **Debris** Grease
Silt Depth: **2** (in.) Deposits Extent: **Light**
Infiltration: **Evidence** Pipe Seal Cond: **Unknown**

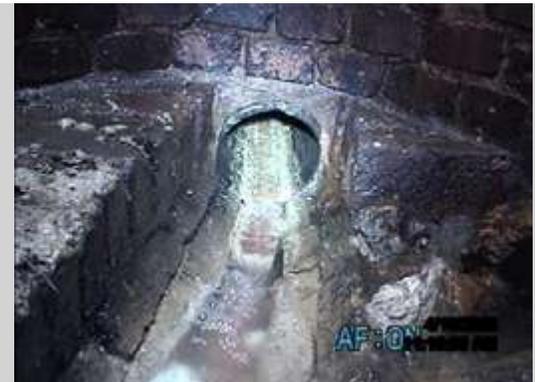
6 O'Clock Inflow

Pipe Height: **6** (in.) Rod and Bar (Angled)
Pipe Material: **Clay** Pipe Lined
Invert Depth: **7.35** (ft.) Flow Characteristics: **Slow**
Deposits: None Mud **Sludge** **Debris** Grease
Silt Depth: **3** (in.) Deposits Extent: **Medium**
Infiltration: **Evidence** Pipe Seal Cond: **Unknown**

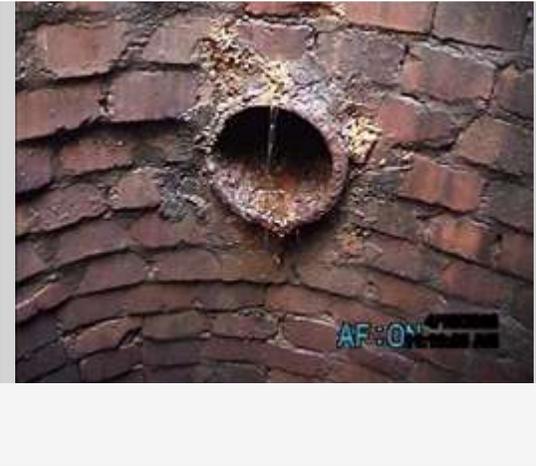
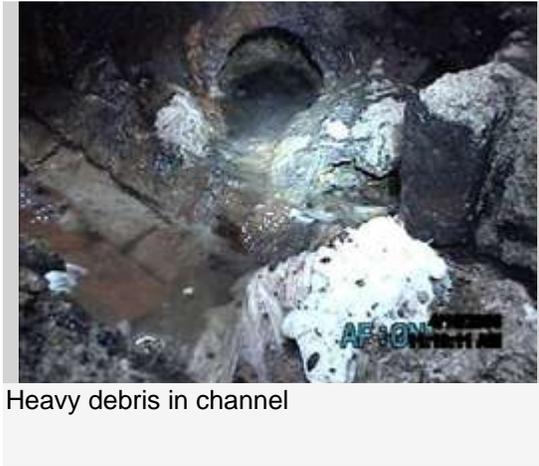
8 O'Clock Inflow

Heavy debris in channel

Pipe Height: **7.2** (in.) Rod and Bar (Angled)
Pipe Material: **Clay** Pipe Lined
Invert Depth: **4.38** (ft.) Flow Characteristics: **Slow**
Deposits: None Mud **Sludge** **Debris** Grease
Silt Depth: **5** (in.) Deposits Extent: **Medium**
Infiltration: **Evidence** Pipe Seal Cond: **Unknown**

Drop: Inside	Rod and Bar
Angled: Yes	Reading: 6.34 (ft.)
	Inv Depth: 7.34 (ft.)
Drop Condition: Partly Clogged	
Connects To: Dead End	
<input type="checkbox"/> Possible Illicit Connection
